LAKE AND POND REMEDIATION, INC.

Service Report

Date: April 3, 2023

Client: Palencia, Marsh Creek CDD

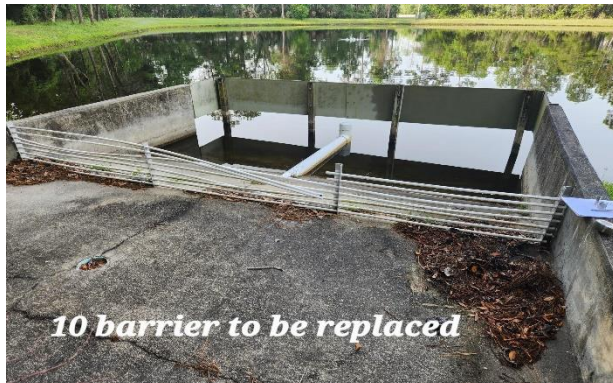
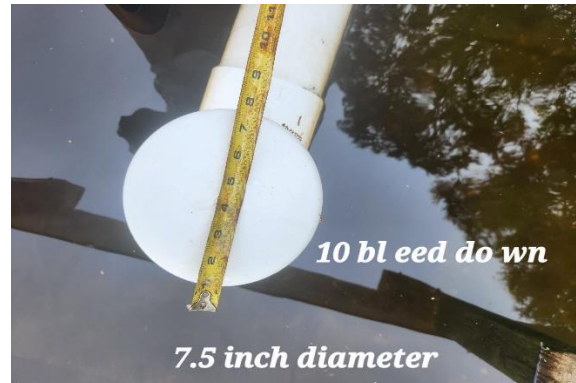
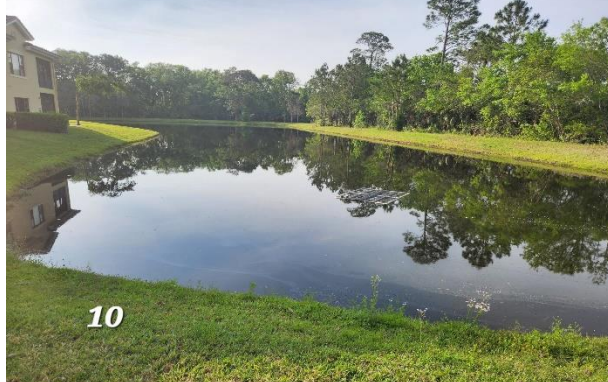
Lake 10: Rated: 10

- There is minor pennywort around the perimeter.
- Minimal trash in the pond.
- The old PVC fish barrier is broken again.
- No alligators observed.

Treatment: I measured for a new fish barrier and a new bleed down barrier.

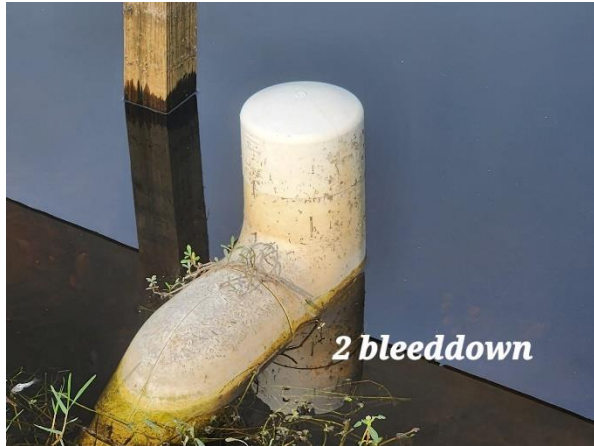
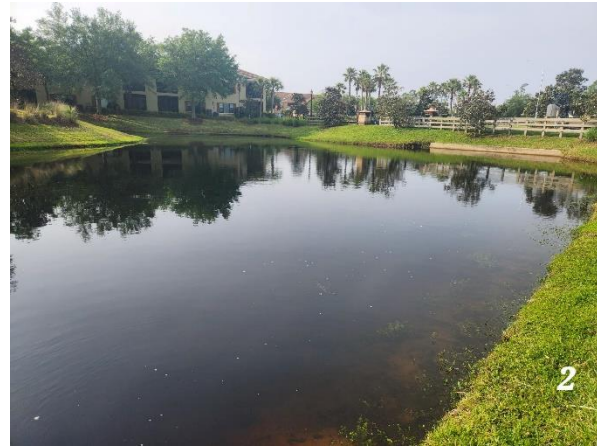
Lake 2: Rated: 8

- Spotty alligatorweed and bacopa.
- Bleed down barrier is missing.
- No gators observed.

Treatment: I treated the alligatorweed by backpack and I measured for the bleed down barrier replacement.

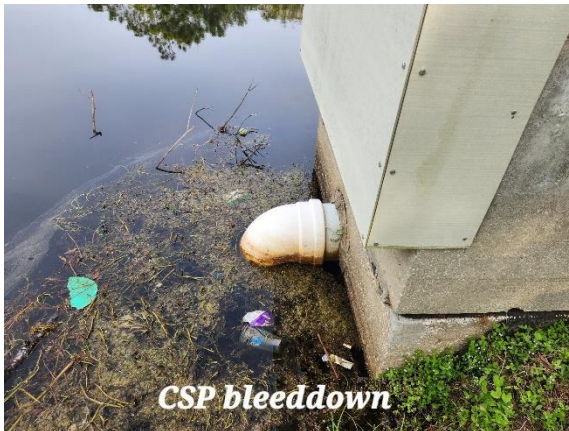
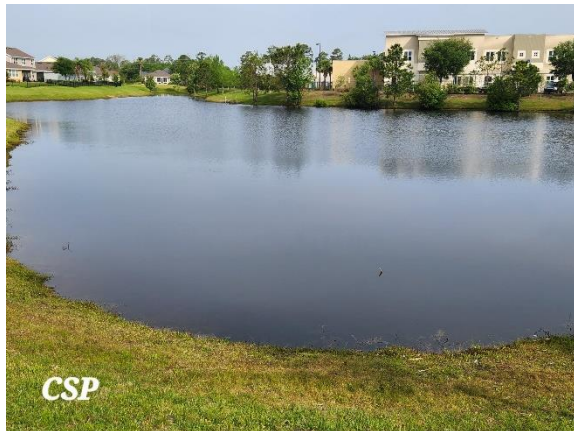
Lake CSP: Rated: 9

- There is some floating debris and trash on the south side.
- No alligators observed.
- Bleed down barrier is missing.

Treatment: I removed the debris and trash and measured for the bleed down barrier.

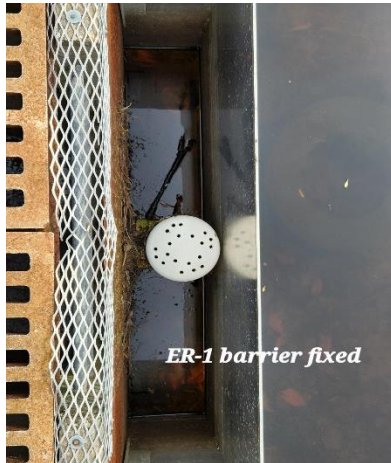
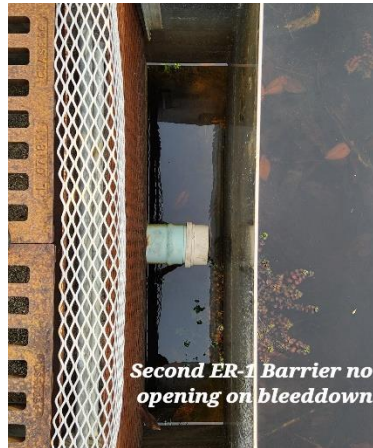
Lake ER-1: Rated: 8

- Spotty submersed bacopa.
- Water level is low.
- No gators observed.

Treatment: I straightened the one bent barrier and measured for the missing bleed down barrier.

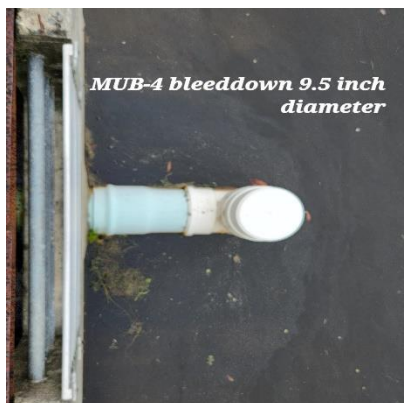
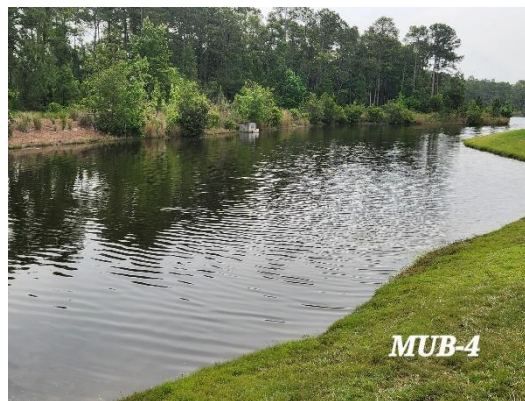
Lake MUB-4: Rated: 10

- There is minimal debris at the north end.
- No alligators observed.

Treatment: I measured for the missing bleed down barrier.

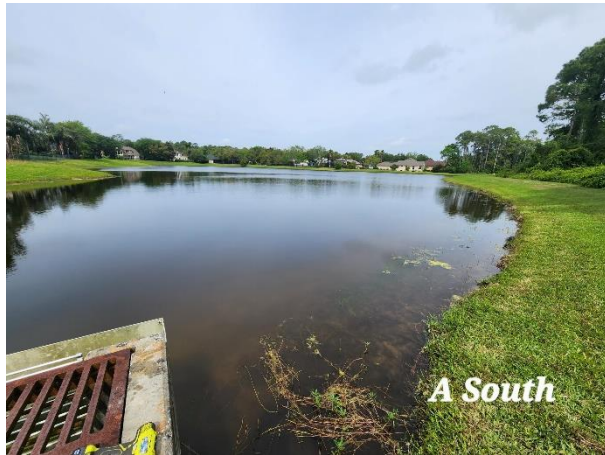
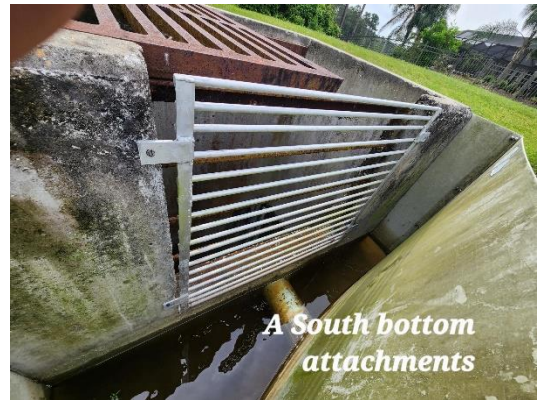
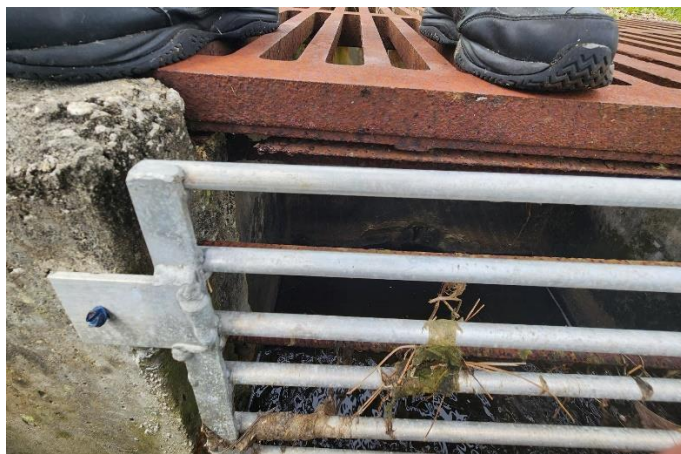
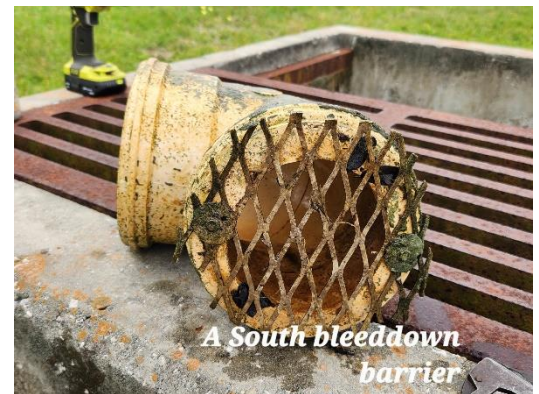
Lake A South: Rated: 8

- Moderate submersed bacopa and some now exposed.
- Water level is low.

Treatment: I attached the bottom of the main barrier by tap cons and was able to remove and photograph the bleed down barrier.

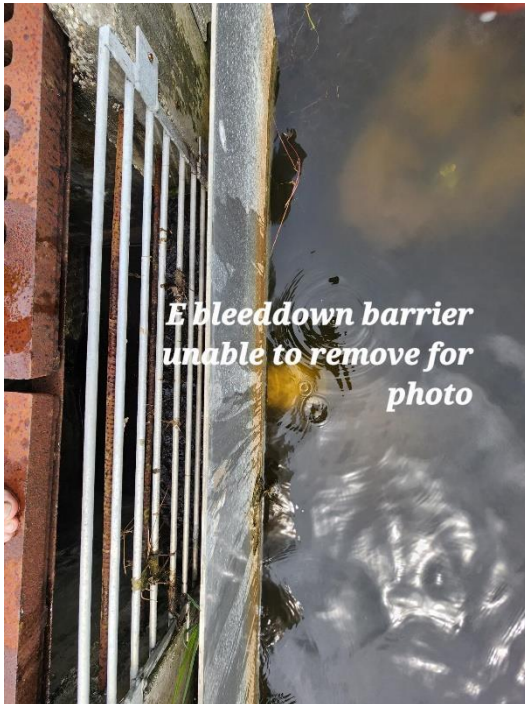
Lake E: Rated: 7

- Minor dead weeds around the perimeter and naiad is starting to grow in the shallows.
- No alligators observed.

Treatment: I attached the one side of the main barrier and found the bleed down barrier intact; however, I was unable to remove and photograph it.

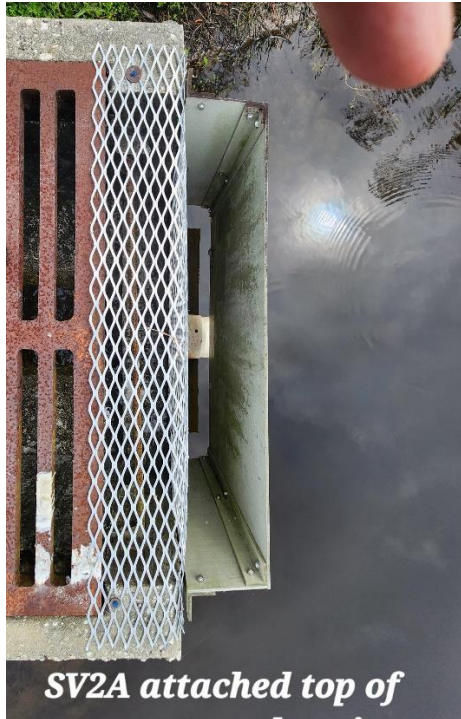
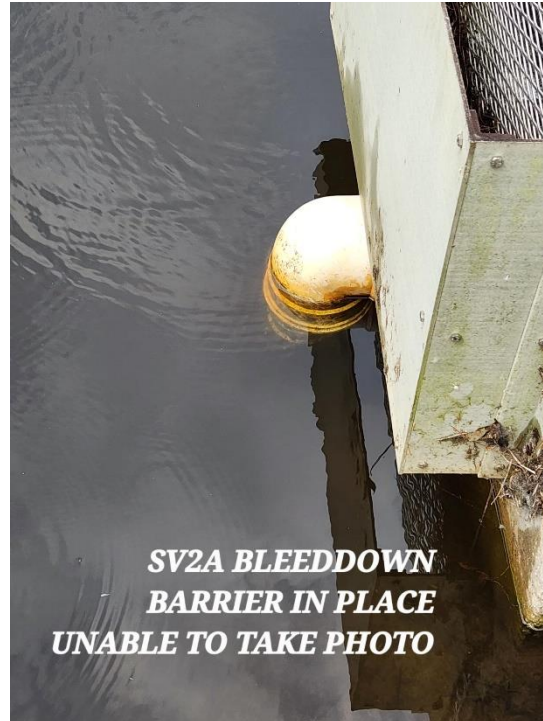
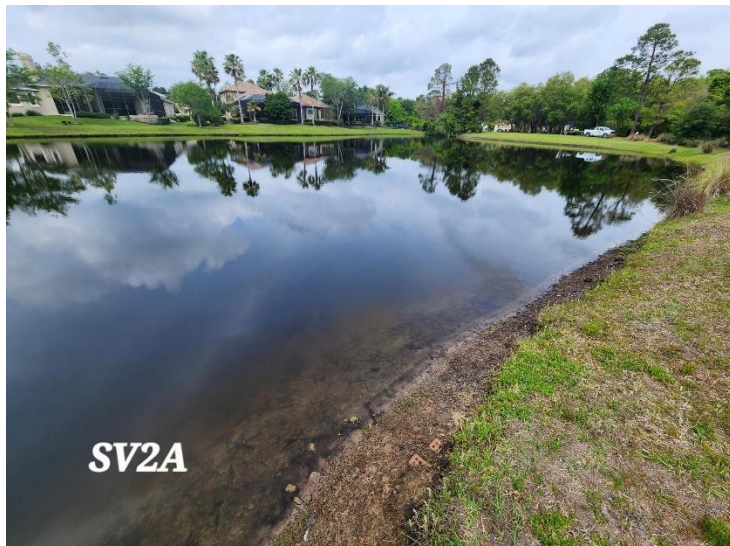
Lake SV2A: Rated: 10

- Minimal grasses.
- Water level is a little low.
- No gators observed.

Treatment: I attached the top of the main barrier and found the bleed down barrier intact but was unable to remove and photograph.
