LAKE AND POND REMEDIATION, INC.

Service Report

Date: September 12, 2023

Client: Palencia, Marsh Creek CDD

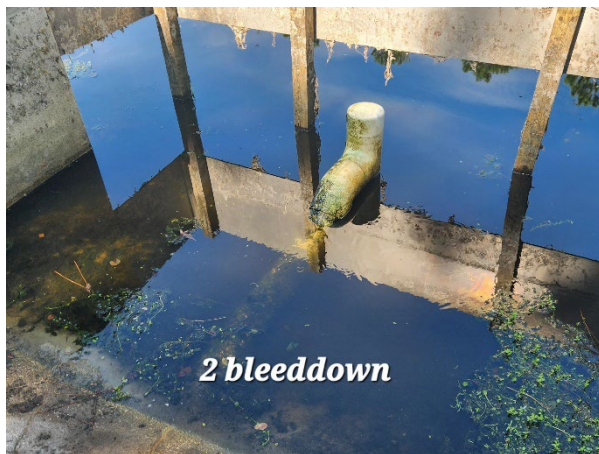
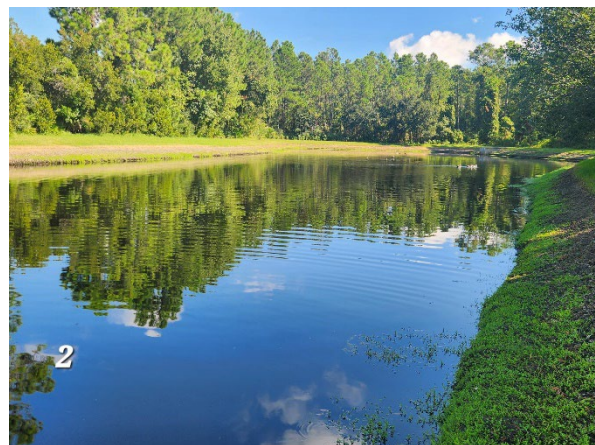
Lake 2: Rated: 6

- Water level is very low from the bleeddown pipe coming off after cleaning the fish barrier.
- Heavy bacopa patches around the perimeter.

Treatment: I replaced the bleeddown pipe so the water level should return to normal after the next rain. I also hand raked some of the bacopa. There is no need for a meeting now.

Recommendations: I plan to stock more grass carp this winter.

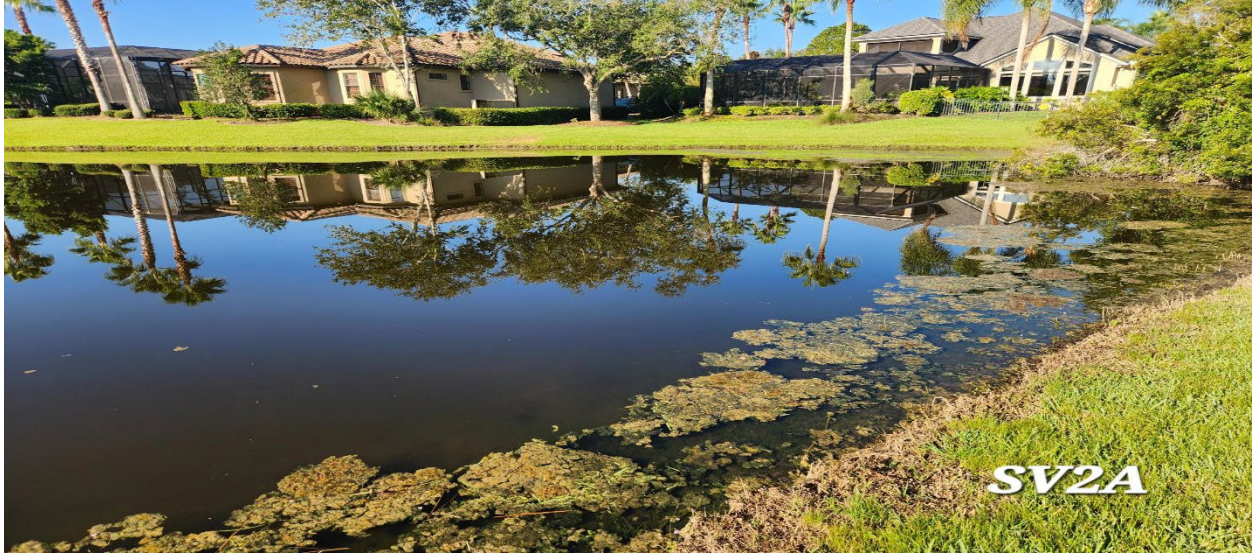
Lake SV2A: Rated: 6

- Floating algae across 5% of pond surface.
- Water level is a little low.

Treatment: I launched the airboat and broke up the algae and then treated it.
Recommendations: I plan to stock more grass carp this winter.
